ON-SITE AIR BAG INVESTIGATION

CASE NO. - 93-07

The 1990 Dodge Daytona was equipped with a driver supplemental restraint system (air bag) which did not deploy as a result of the right front impact. The driver of the vehicle (28 year-old female) was not wearing the available, active, three-point, lap and shoulder belt. The driver was ejected out the backlight and was found just west of the Daytona's final rest position. She sustained fatal injuries including multiple lower left rib fractures and a massive hemothorax (i.e., estimated at between 2000-3000 ccs) which resulted in cardio-pulmonary arrest from exsanguination. The driver of the Daytona was listed on the Police Accident Report as sustaining a "K" (fatal) injury as a result of her crash. The driver (33 year-old male) of the Fiero was listed on the Police Accident Report as restrained and sustaining an "A" (incapacitating) injury.

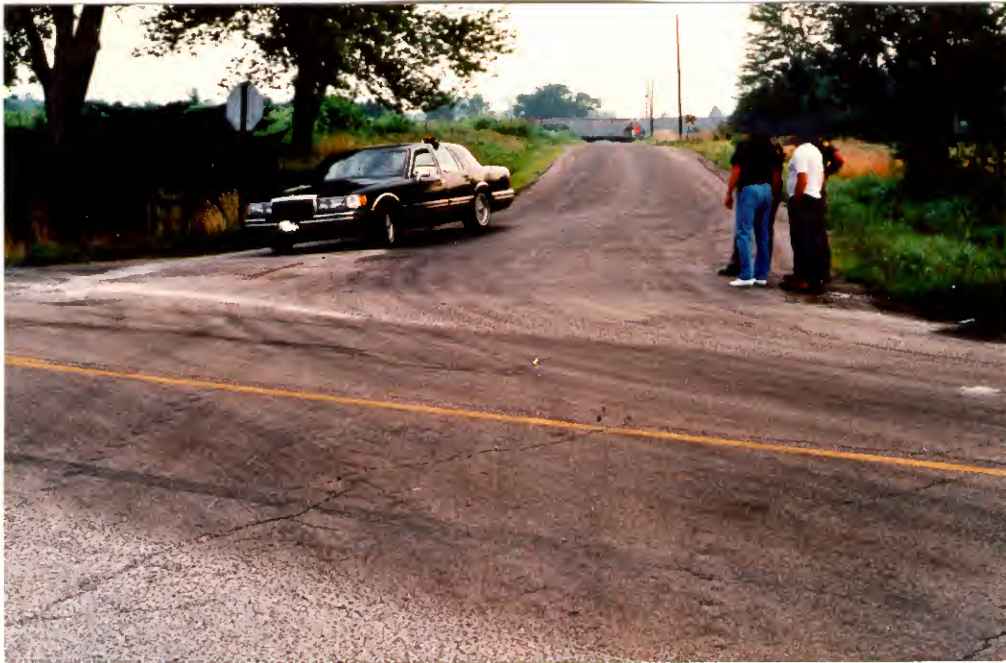
# 01 -- [REDACTED] 1993  
 [REDACTED] Illinois  
 TRC/IU: 93-07, Task: 0103  
 ISP Photo: Daytona's north-  
 ward approach to impact area

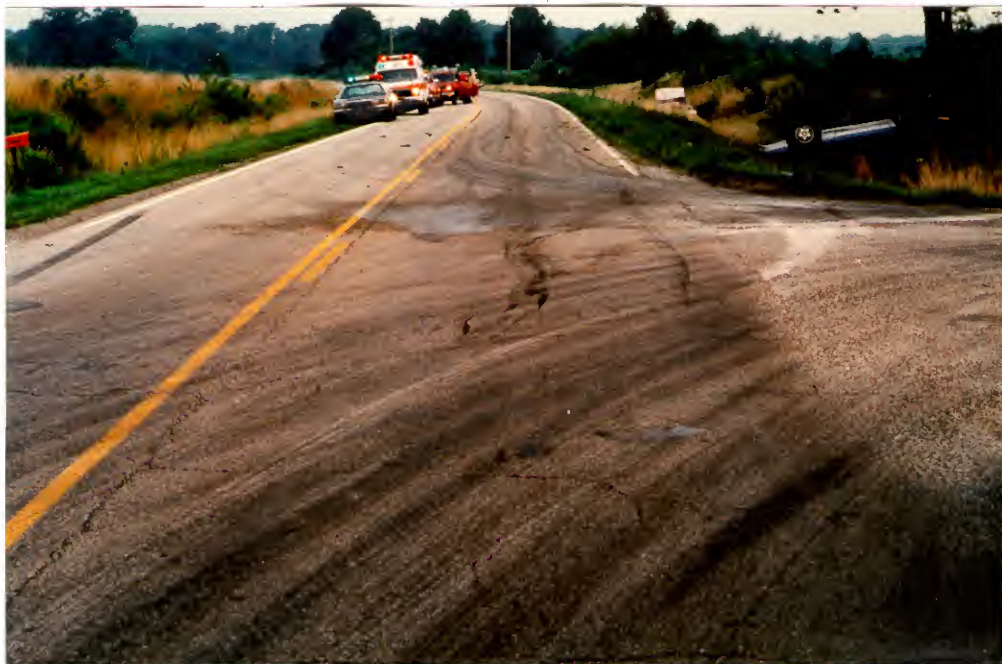
# 02 -- [REDACTED] 1993  
 [REDACTED] Illinois  
 TRC/IU: 93-07, Task: 0103  
 ISP Photo: Fiero's westward  
 approach to impact area

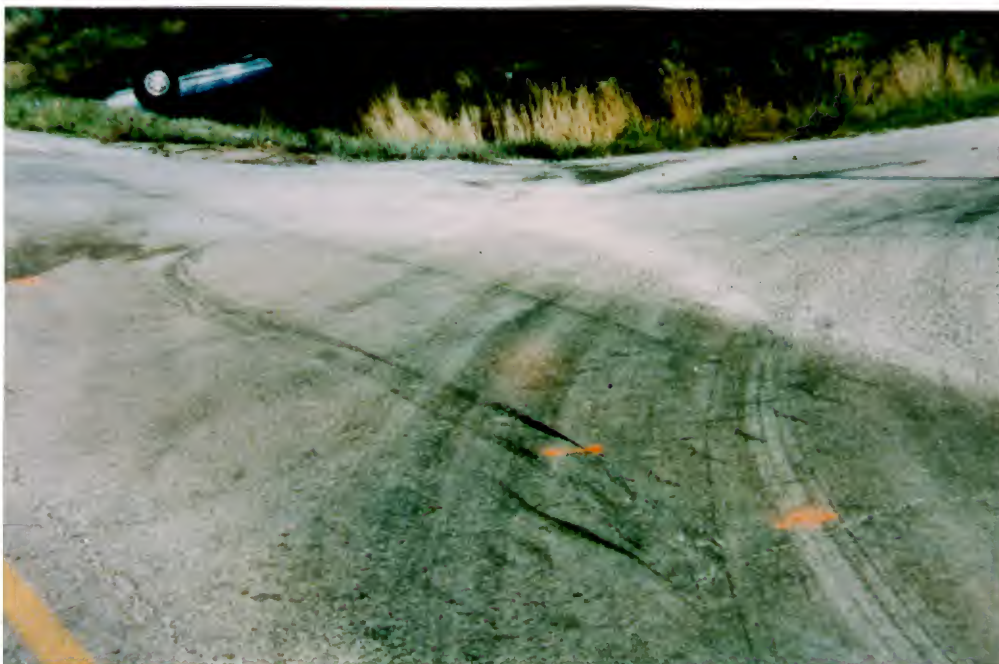
# 05 -- [REDACTED] 1993  
 [REDACTED] Illinois  
 TRC/IU: 93-07, Task: 0103  
 ISP Photo: impact area and  
 Daytona's post-impact scuffs

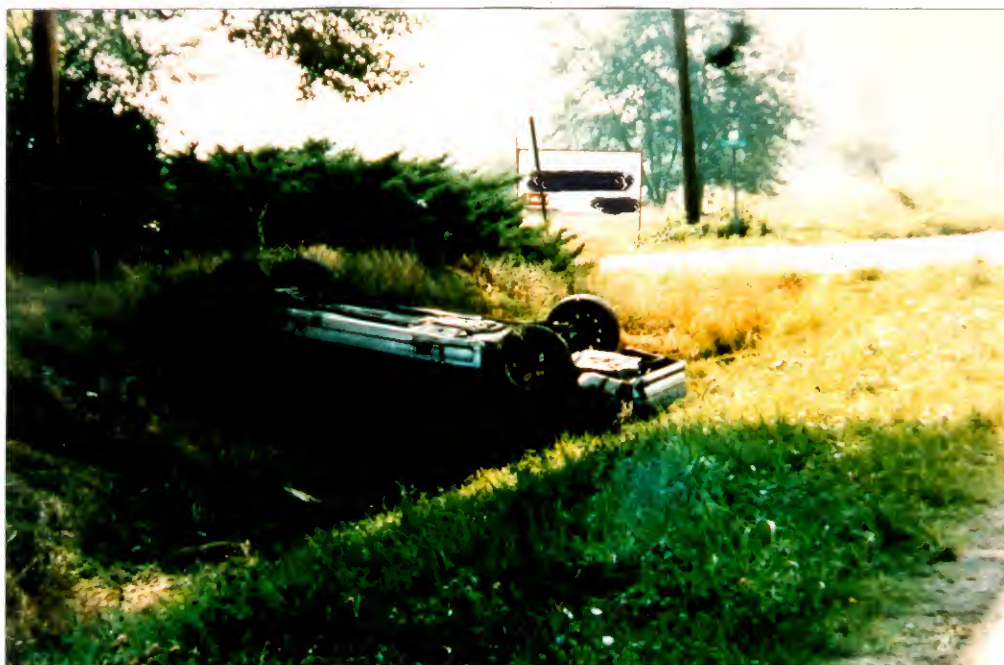
# 06 -- [REDACTED] 1993  
 [REDACTED] Illinois  
 TRC/IU: 93-07, Task: 0103  
 ISP Photo: Daytona's final  
 rest position facing north

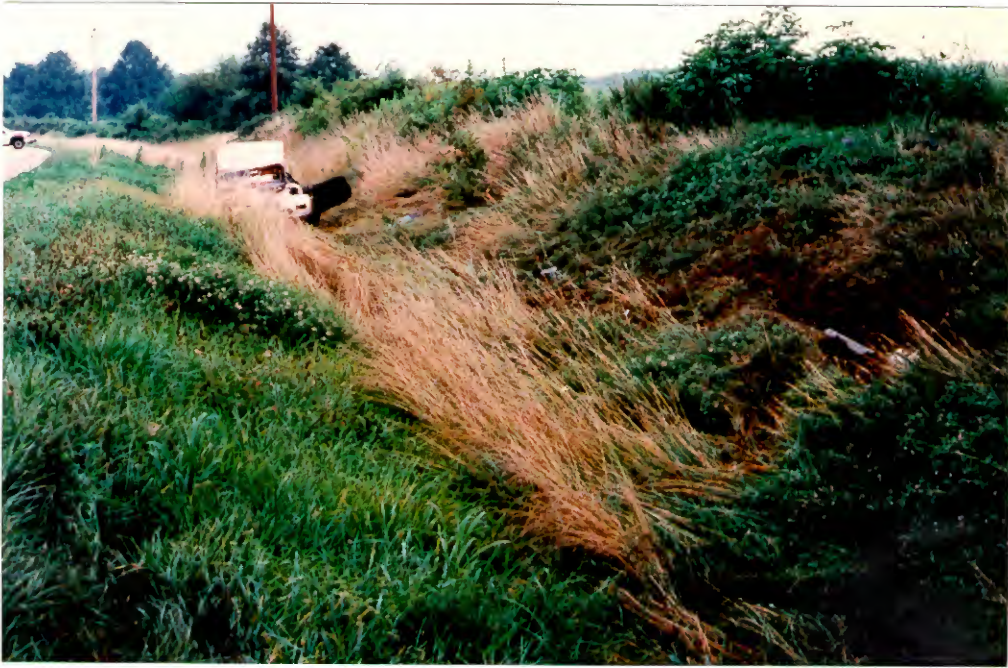
# 07 -- [REDACTED] 1993  
 [REDACTED] Illinois  
 TRC/IU: 93-07, Task: 0103  
 ISP Photo: Fiero's impact  
 with embankment & final rest

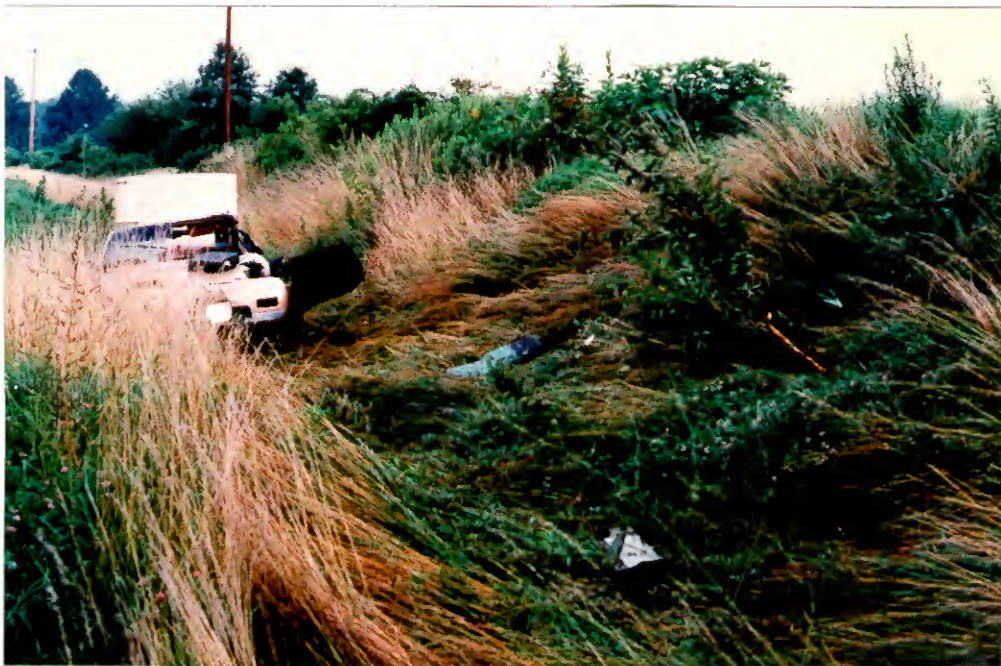
# 08 -- [REDACTED] 1993  
 [REDACTED] Illinois  
 TRC/IU: 93-07, Task: 0103  
 ISP Photo: Fiero rotated  
 CCW & went westward to FR

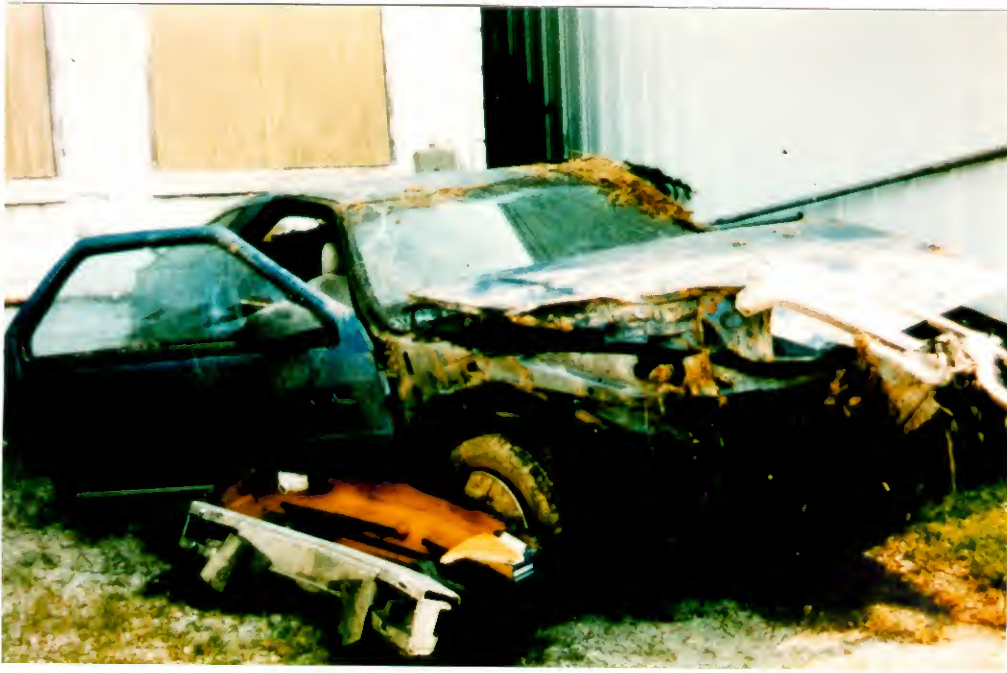
# 17 - [REDACTED], 1993  
 [REDACTED] Illinois  
 TRC/IU: 93-07, Task: 0103  
 ISP Photo: Daytona front &  
 right side at body shop

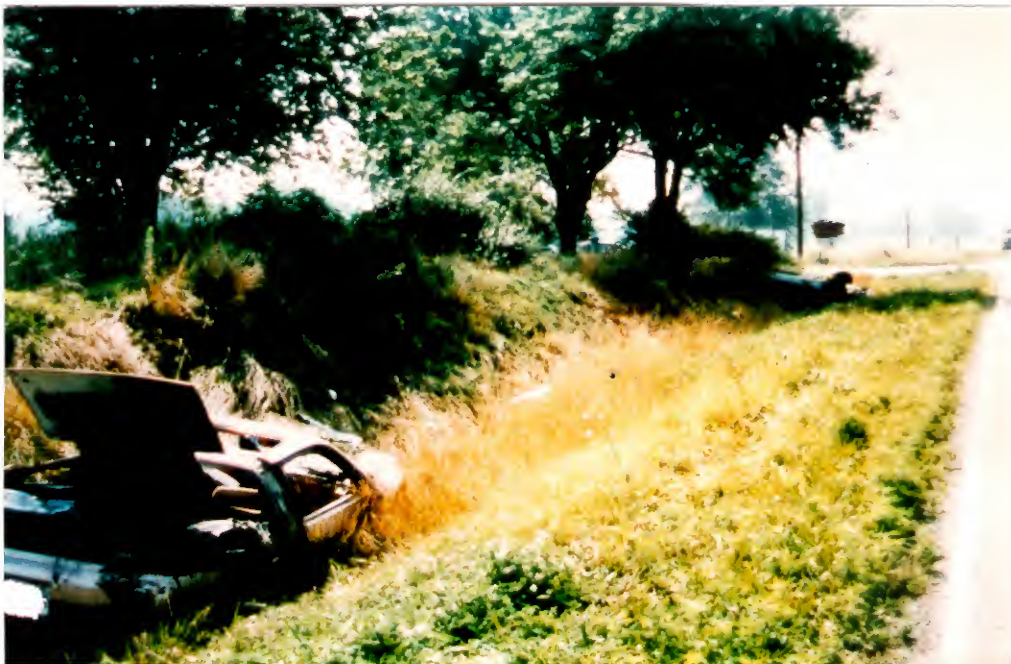
# 21 -- [REDACTED], 1993  
 [REDACTED] Illinois  
 TRC/IU: 93-07, Task: 0103  
 ISP Photo: looking NE at  
 proximity of Fiero & Daytona

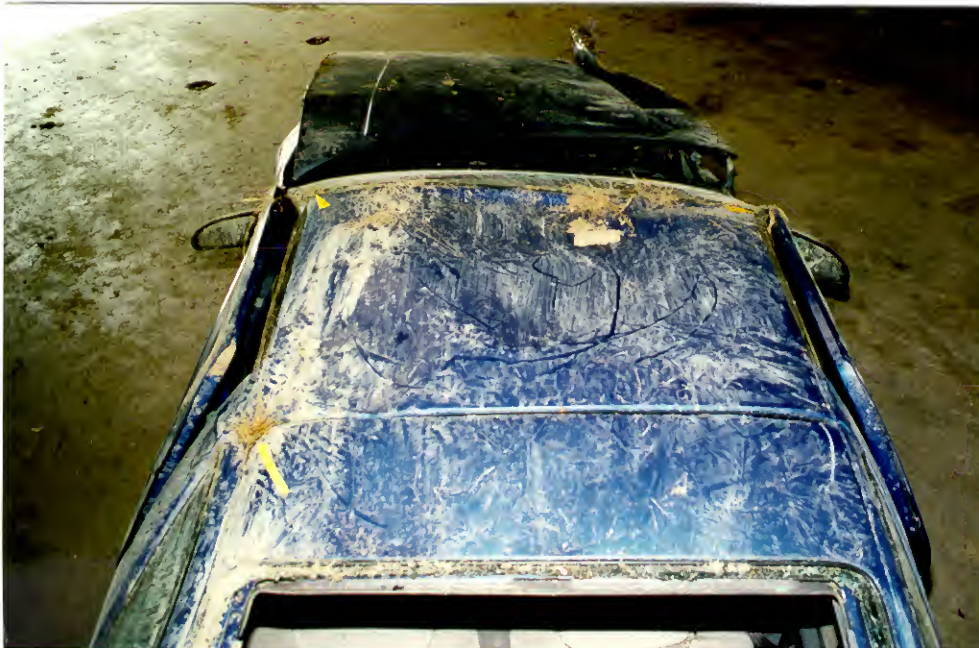
# 36 -- [REDACTED], 1993  
[REDACTED], Illinois  
TRC/IU: 93-07, Task: 0103  
TRC Photo: rollover damage  
of roof area from top-back

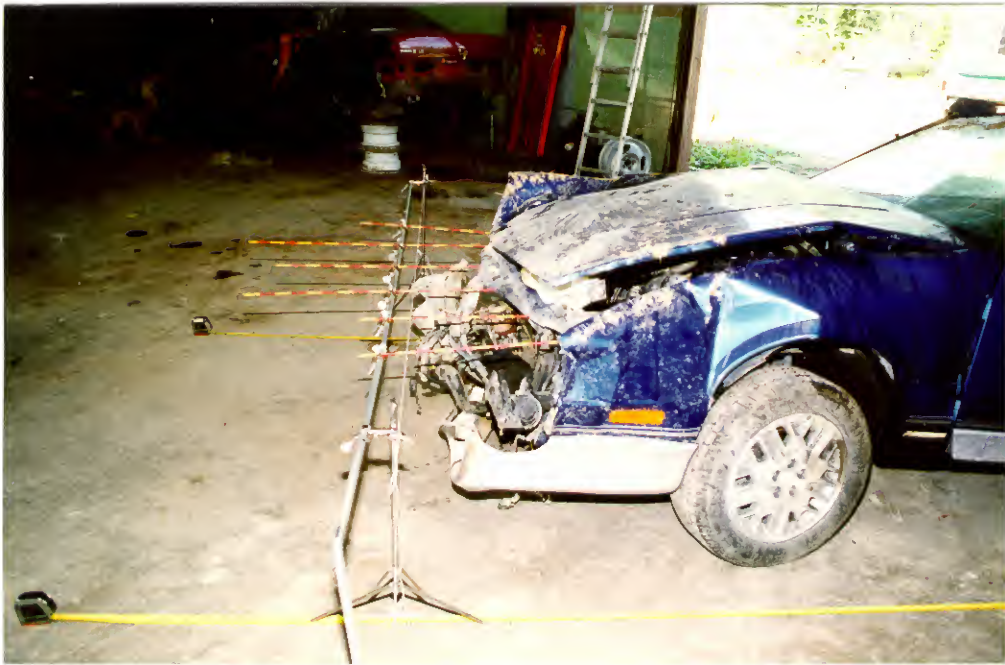
# 39 -- [REDACTED] 1993  
 [REDACTED] Illinois  
 TRC/IU: 93-07, Task: 0103  
 TRC Photo: front damage and  
 contour gauge from left

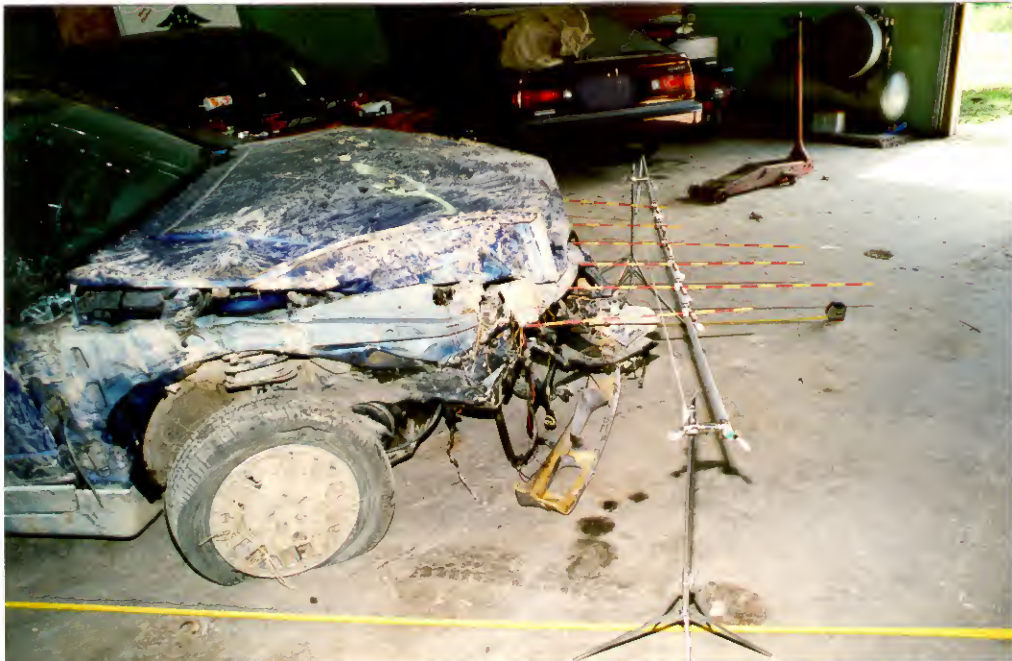
# 40 -- [REDACTED] 1993  
 [REDACTED] Illinois  
 TRC/IU: 93-07, Task: 0103  
 TRC Photo: front damage and  
 contour gauge from right

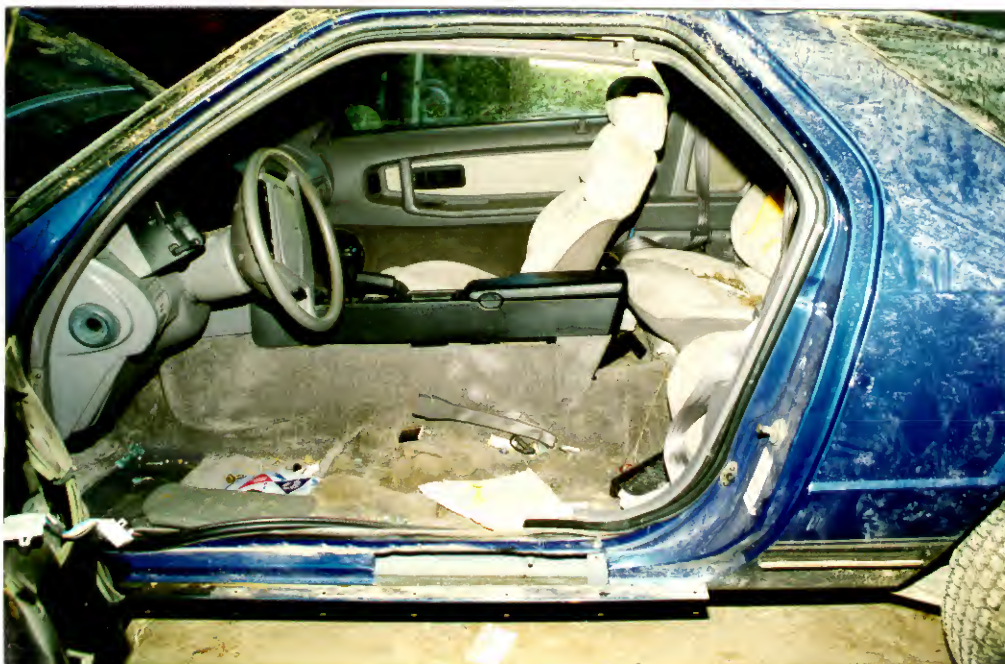
# 41 -- [REDACTED] 1993  
 [REDACTED] Illinois  
 TRC/IU: 93-07, Task: 0103  
 TRC Photo: driver's area  
 after seat removed by ISP

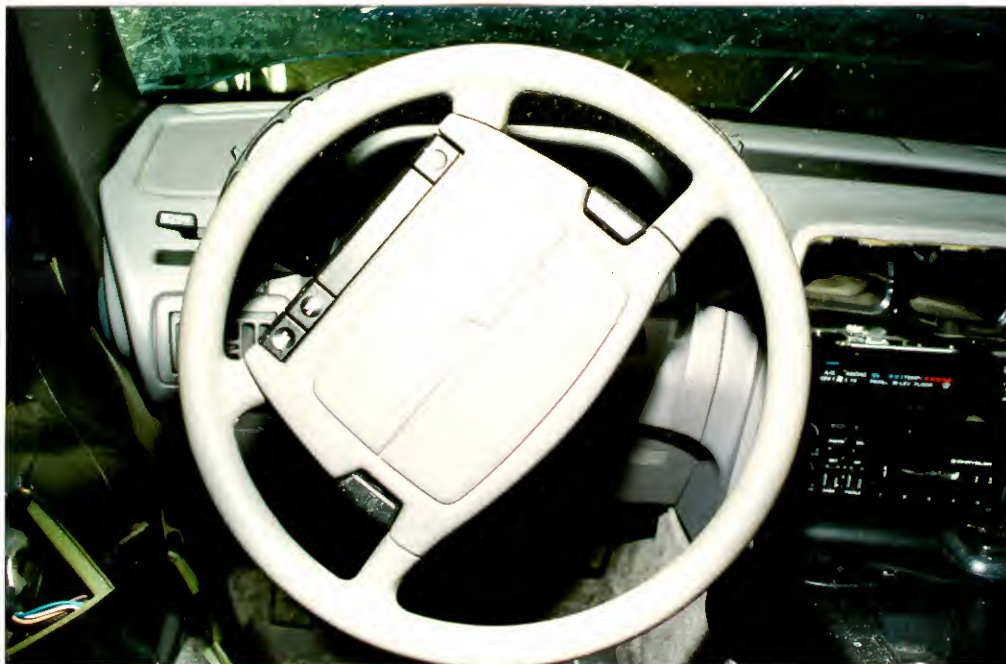
# 44 -- [REDACTED] 1993  
 [REDACTED], Illinois  
 TRC/IU: 93-07, Task: 0103  
 TRC Photo: closeup steering  
 wheel & air bag cover

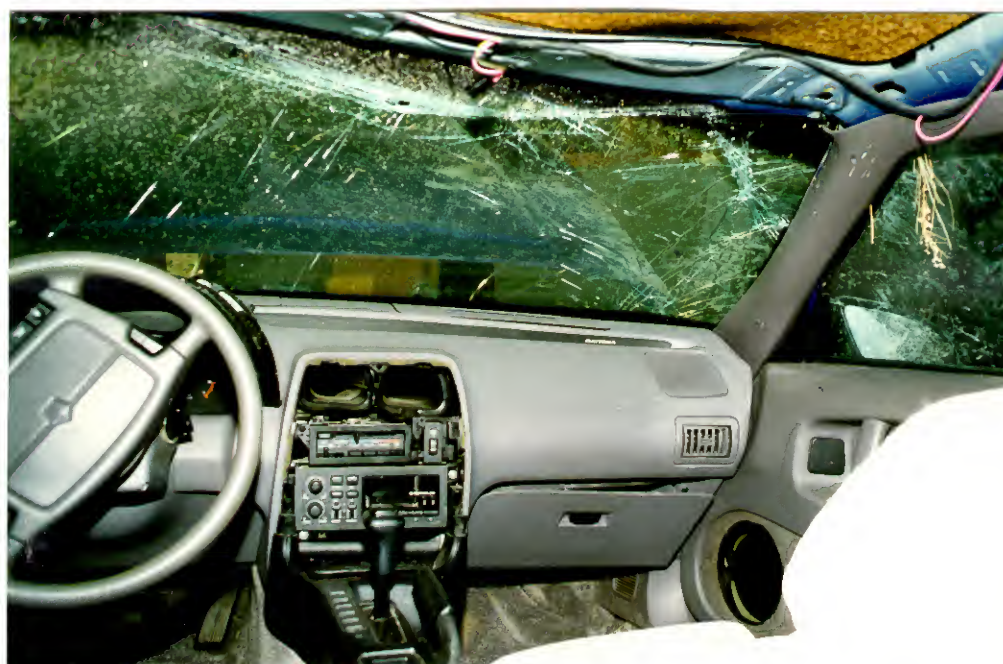
# 46 - [REDACTED] 1993  
[REDACTED], Illinois  
TRC/IU: 93-07, Task: 0103  
TRC Photo: center & right  
instrument panel areas

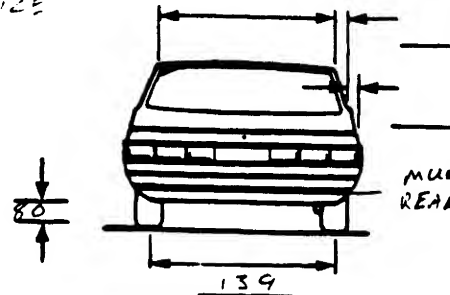
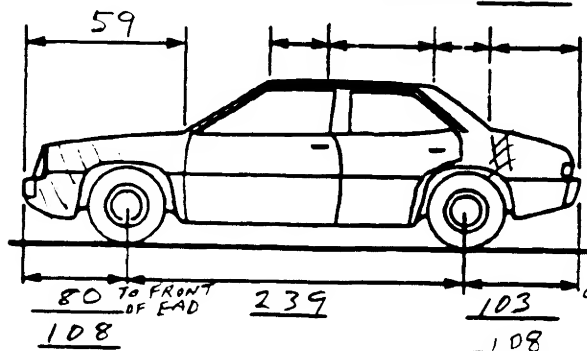
GRASS IN SEAM BETWEEN  
 HATCH AND ROOF
